# NOvA Quality Control

Sarah Budd

Argonne National Lab

July 15, 2010

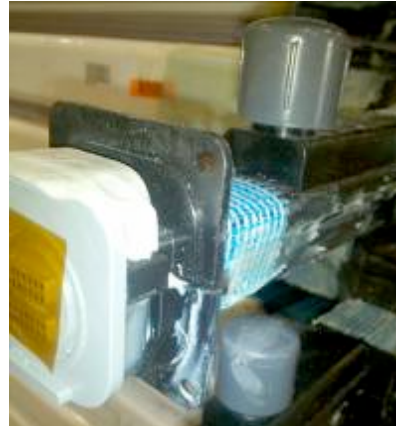
Too much glue

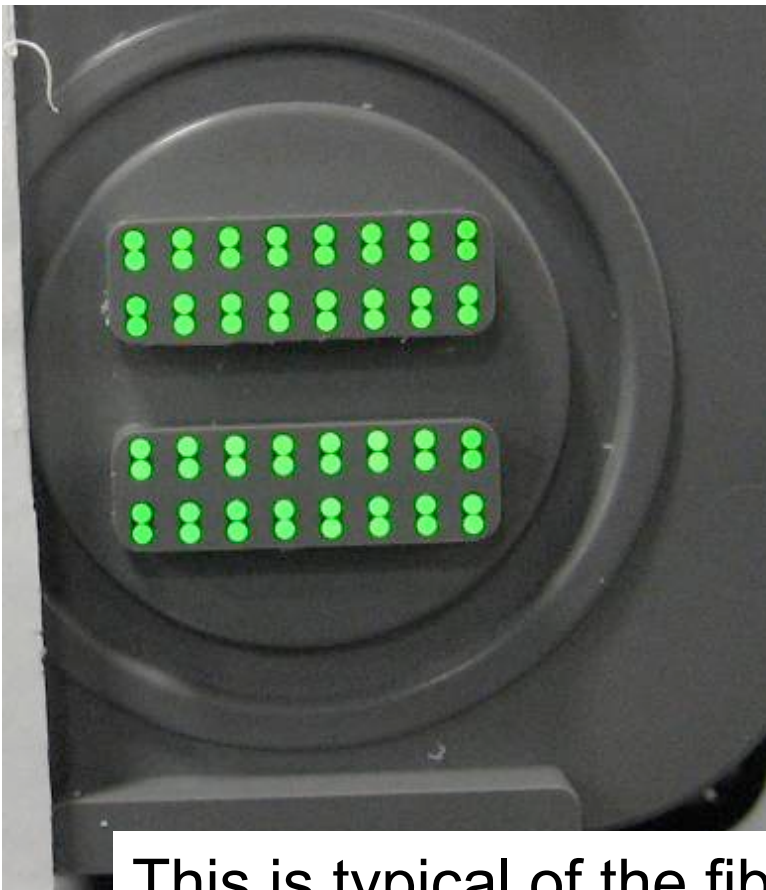
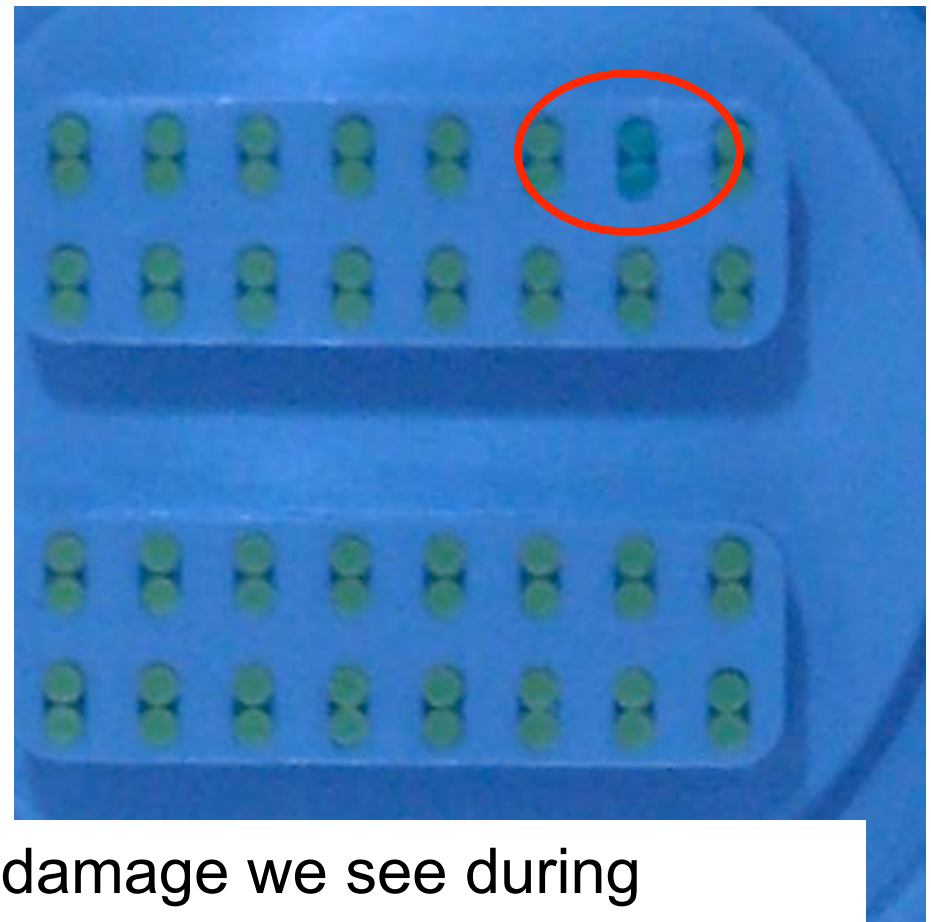
This is typical of the fiber damage we see during shipping, and catch with the module QC.

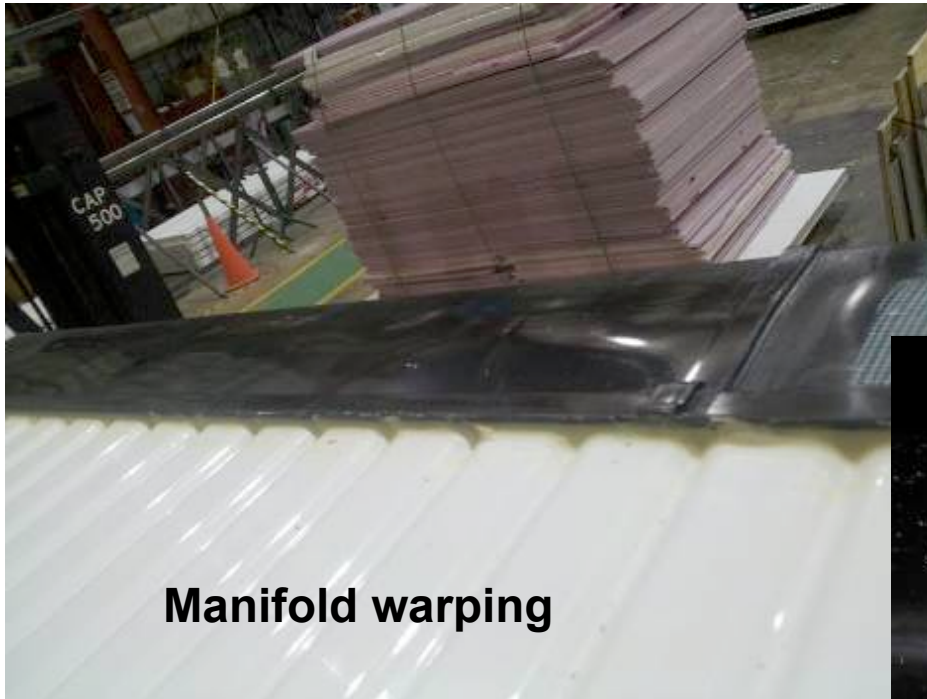
**Manifold warping**

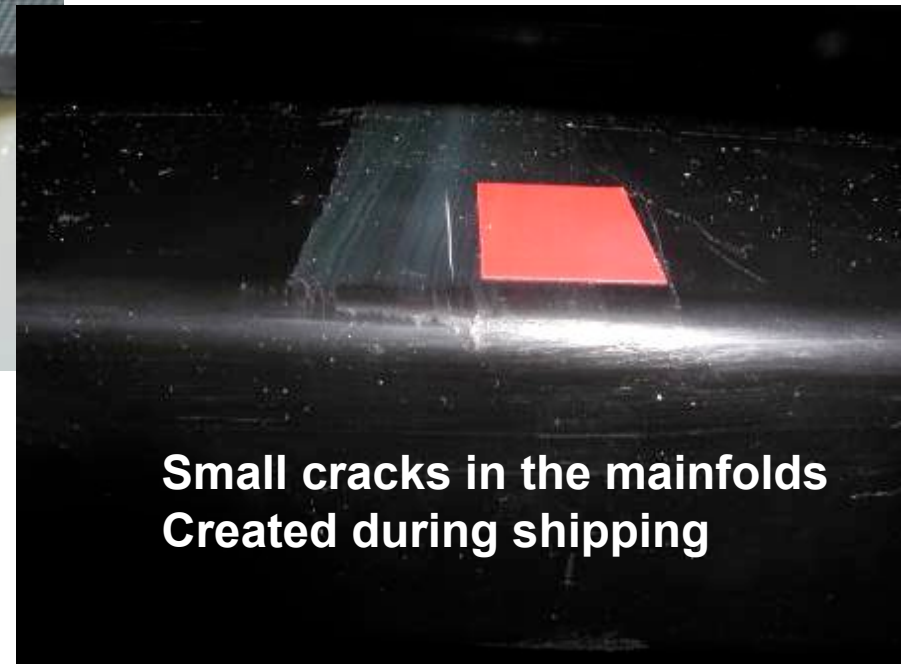
**Small cracks in the manifolds  
Created during shipping**
